# FIELD REPORT

## SERVICE AND KNOWLEDGE SET ISCO APART ON SPILLWAY REPAIR

Spillway Pipe Replacement

Wimberley, Texas

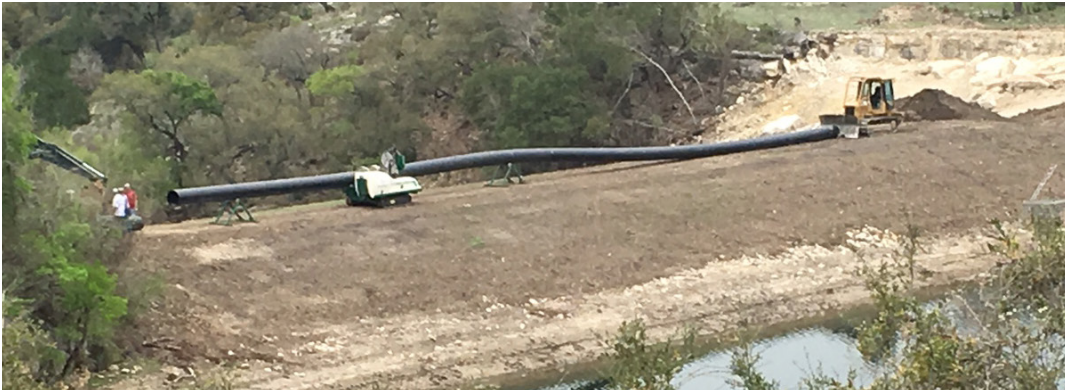
Durable, corrosion-free pipe installed in place of leaking corrugated metal pipe in Texas lake.

ISCO provided 240 feet of 24-inch DR17 and DR26 HDPE pipe, as well as three wall anchor fittings. HDPE is joined via heat fusion, making the joint stronger than the pipe itself. ISCO not only provided the pipe material for the job, but also fusion service consultation, making installation a simple process. ISCO’s focus on the whole job, not just supplying the pipe, made this job a success.

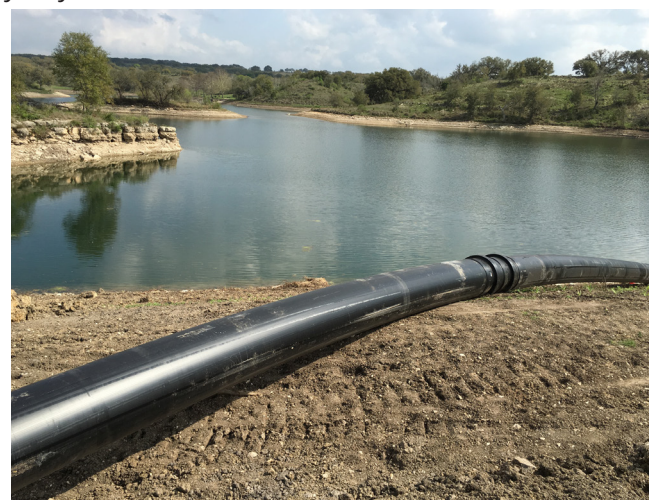
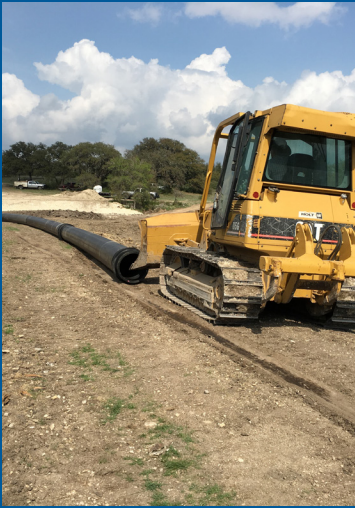
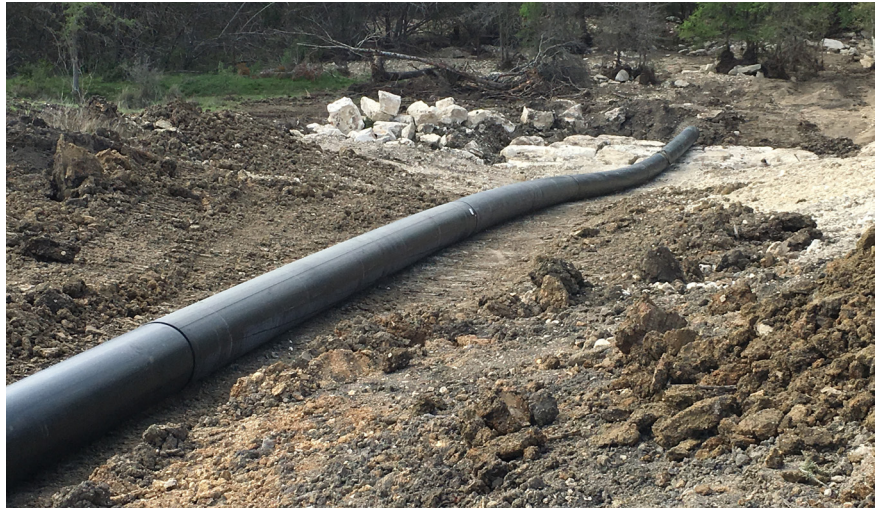
Massive floods destroyed a 24-inch metallic spillway pipe.

ISCO provided 240 feet of DR17 and DR26 pipe with three wall anchor fittings as well as fusion service consultation.
