Field Report www.isco-pipe.com 1-800-345-ISCO

Southern California Reservoir Inlet Pipe Project Encounters Tight Space

San Clemente, CA

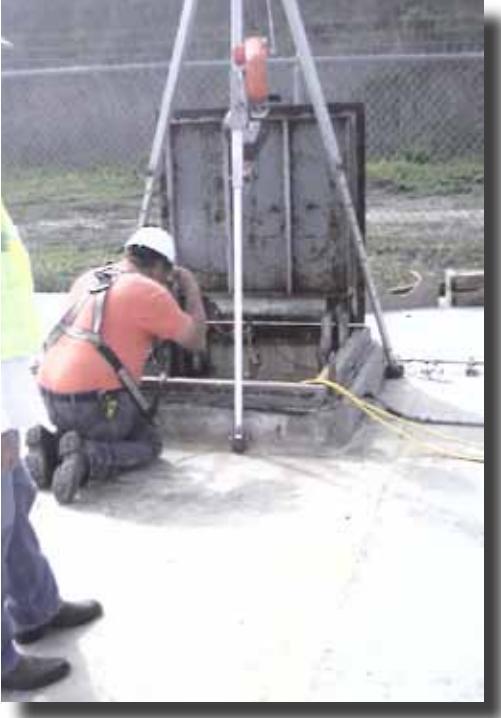
The square entrance point to the storage tank, measuring at only 36-inches wide.

From the start of the installation, there was one problem that had to be addressed. The only access to the reservoir storage tank was through a 36-inch square access way at the top. The small access point reached 22 feet from the top down to the floor of the tank. The contractor on the project, NEWest Construction, needed a way to fuse the replacement pipe once it was inside the storage tank.

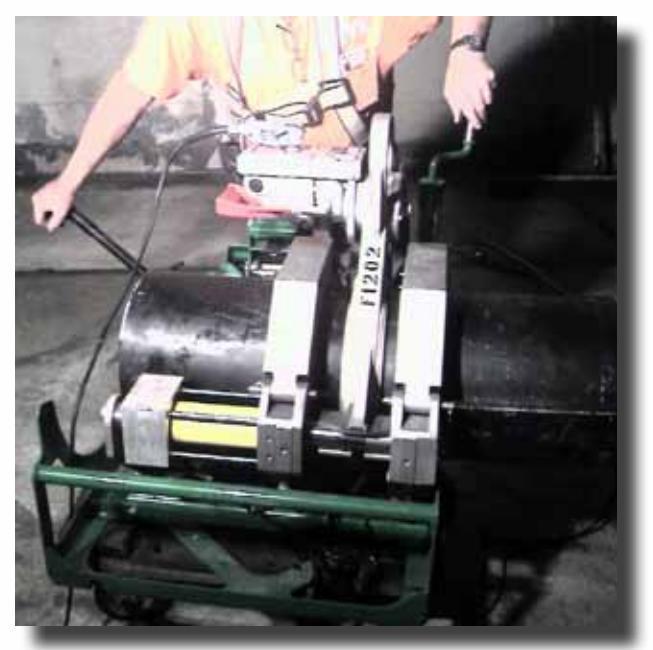
Pipe being fused with McElroy fusion unit inside the water tank

After much thought and discussion, ISCO representative Darin Predmore offered another solution, the McElroy DynaMc[™] 412 hand pump fusion unit. Both the 2-Jaw and 4-Jaw units had a maximum width of only

32-inches, which made the unit an option to get into and through the 36-inch reservoir access way. The hand pump does not require hydraulics and is lightweight, which made fusion easy and fast.

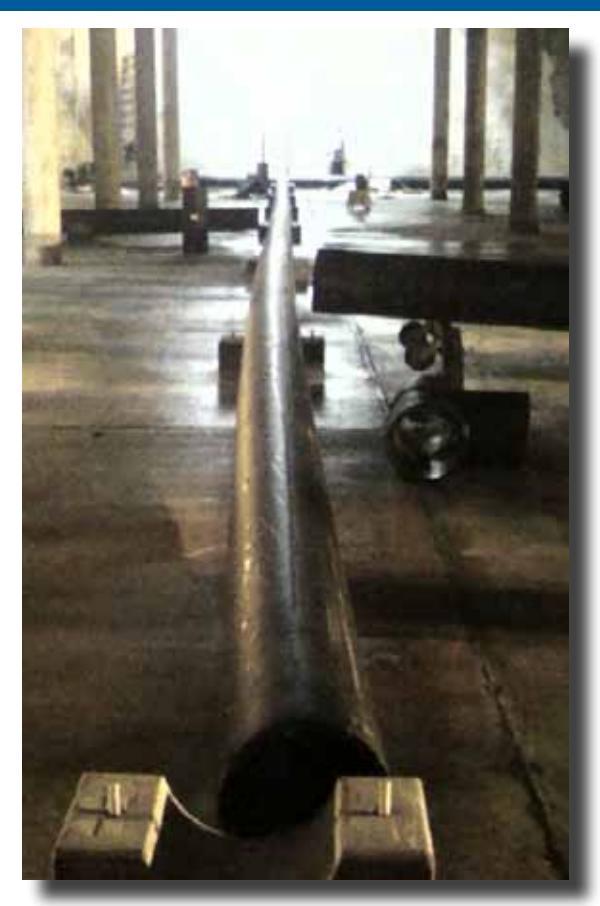
HDPE pipe inside the storage tank waiting to be fused.

ISCO also supplied 280 feet of 12-inch DR 17 high-density polyethylene (HDPE) pipe, as well as fittings and a fabricated outlet structure that ISCO made for any overflow. After a test joint was made using the fusion unit and a bend back test was successfully completed, the contractor was on their way to completing the fusion job on time. The bend back test was so successful that daily tests were not required by the inspector, saving the contractor money.

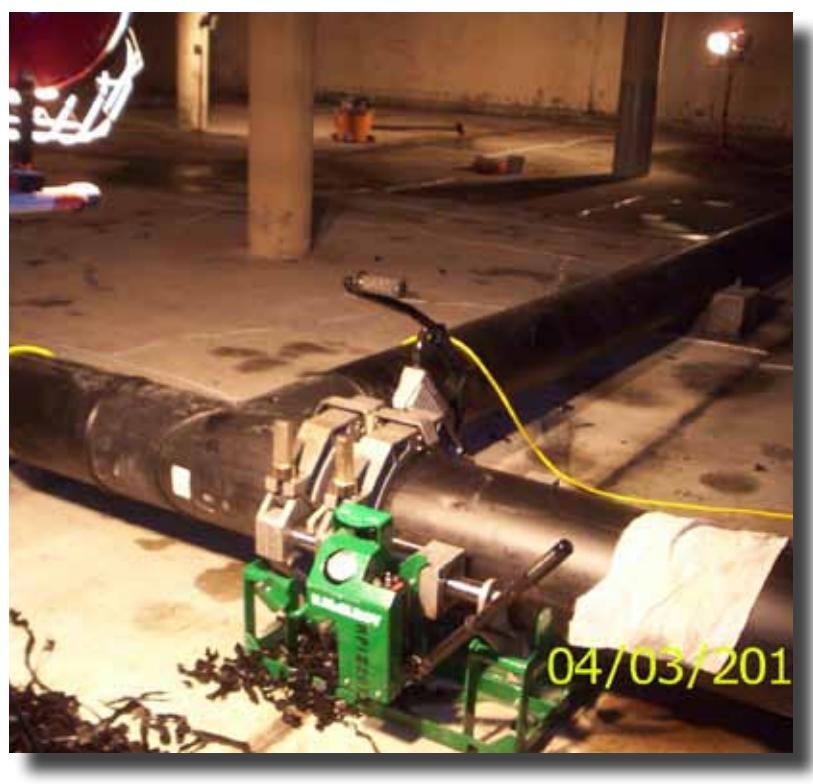
HDPE pipe being fused and installed inside the storage vault.
